## A Survey of Thatched Buildings in Scotland

Thatch Survey of Scotland  
2014-15

A photographic survey of thatched buildings in Scotland, surveyed between May 2014 and August 2015 by Zoe Herbert (SPAB Scotland Officer), on behalf of the Society for the Protection of Ancient Buildings.

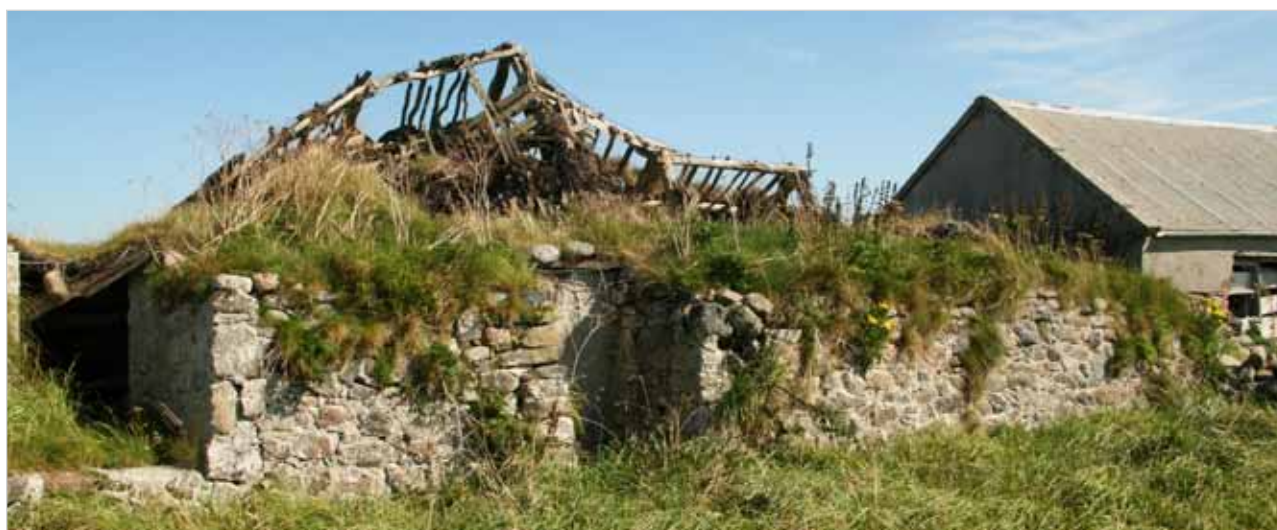
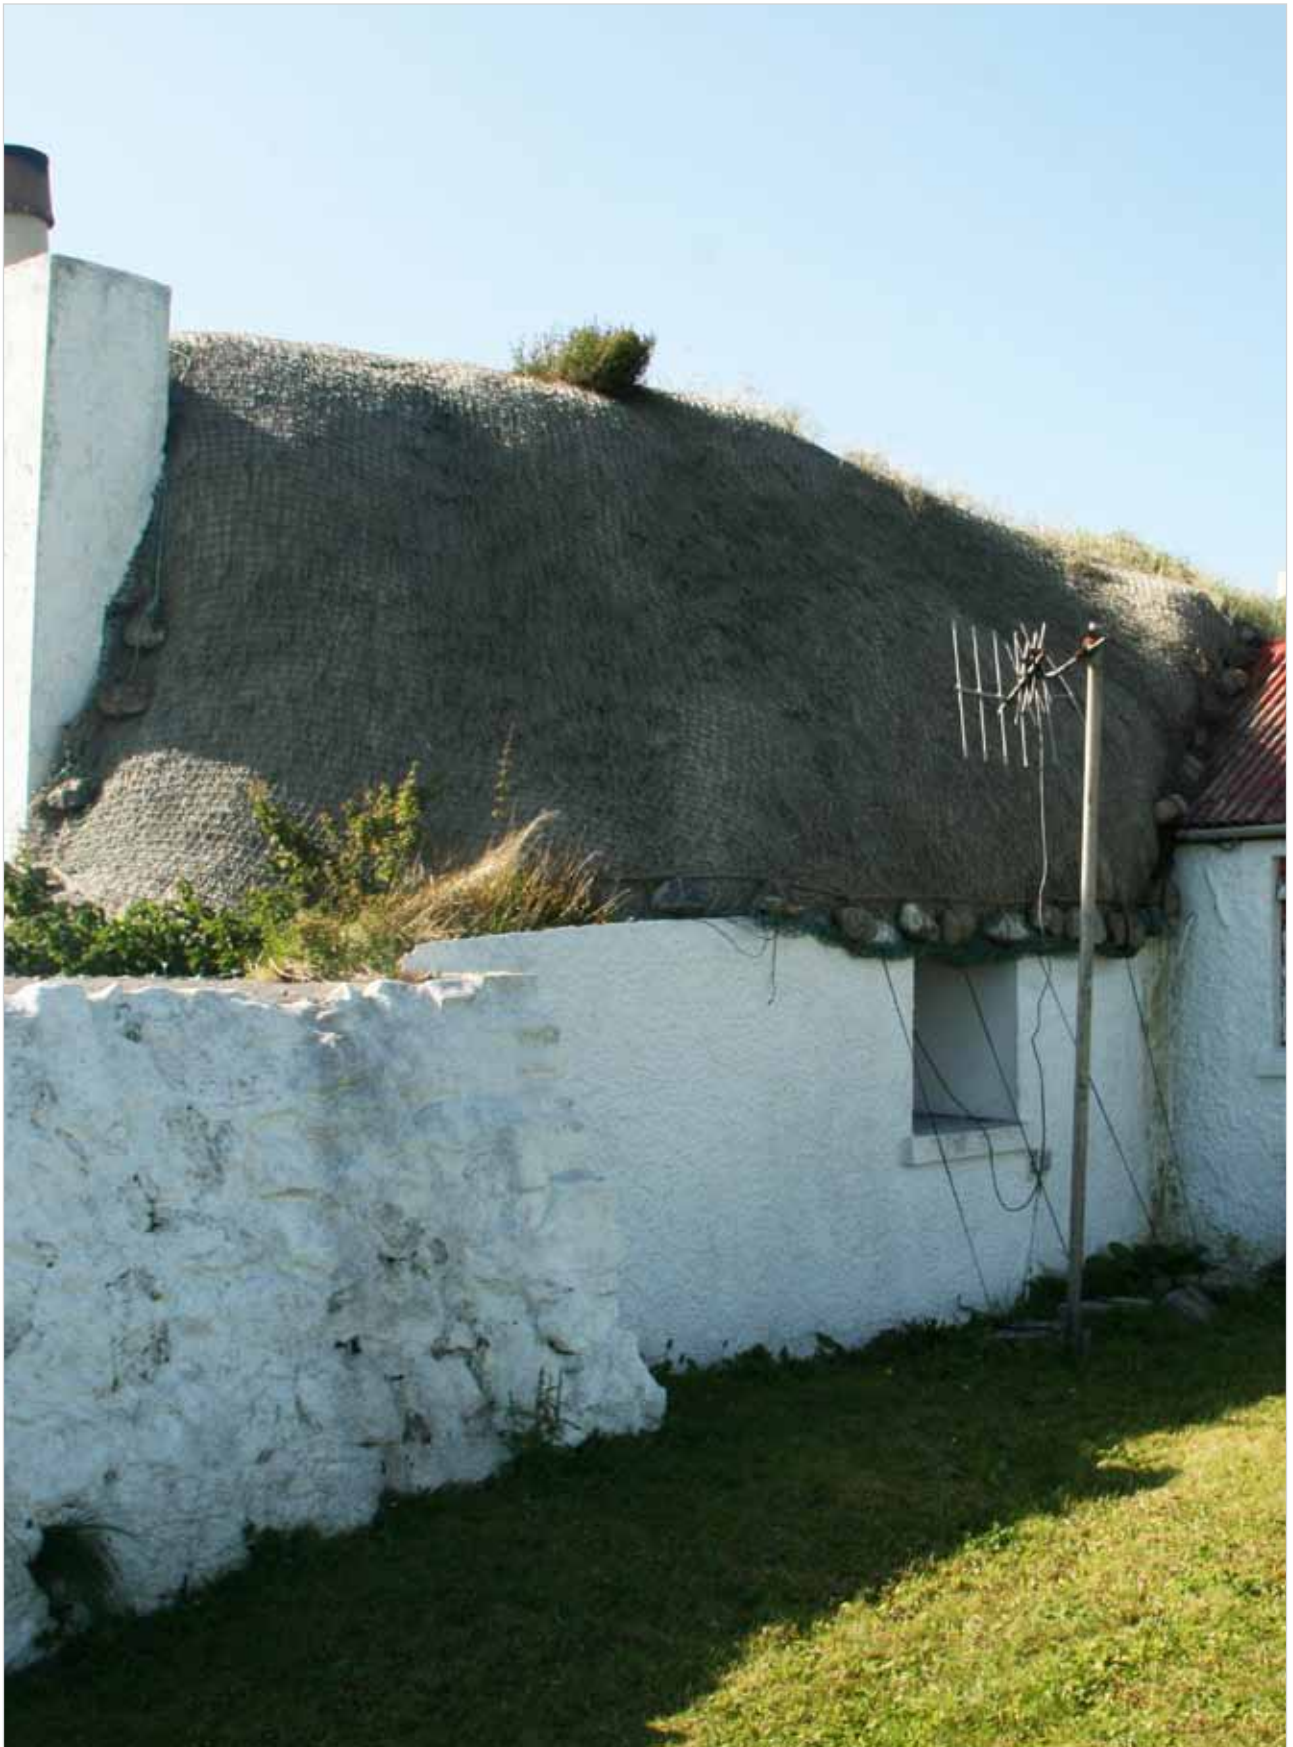
**Additional Notes:** ..... Listing description reads 'Earlier 19th century traditional single storey 2 bay cottage. Single chimney to north gable: piended thatched roof with thatch overhanging eaves. Corrugated iron roofed extension to west'. Noted in the Thatched Building Survey of Tiree, Coll and Mull (1986) as being recently re-roofed and re-thatched in 1983-4, and only recently vacated by a family at that time but in use as a store, with apparently an interconnecting passage to the new build through the south gable. The roof structure has mostly collapsed, along with the thatch. There remains some highly deteriorated evidence of thatching material as well as netting, and what remains is heavily overgrown with vegetation. It has been on the Buildings at Risk Register since 2009 (BAR reference number 3875).

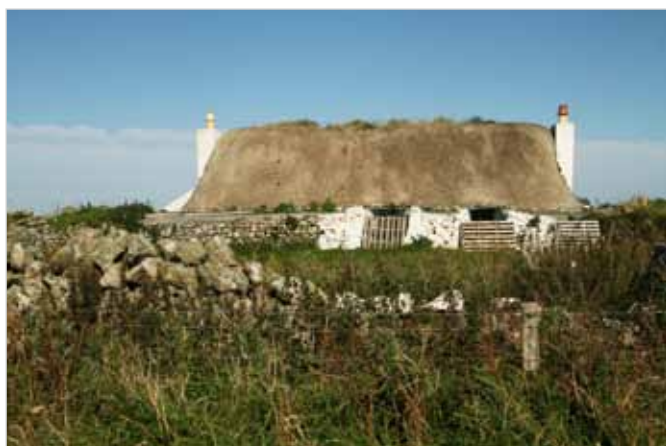
7 Balevullin – Argyll & Bute

..... The thatch itself is in good condition; however, there is some grassy vegetation growth along the ridge and where

..... the thatch meets the wallheads.

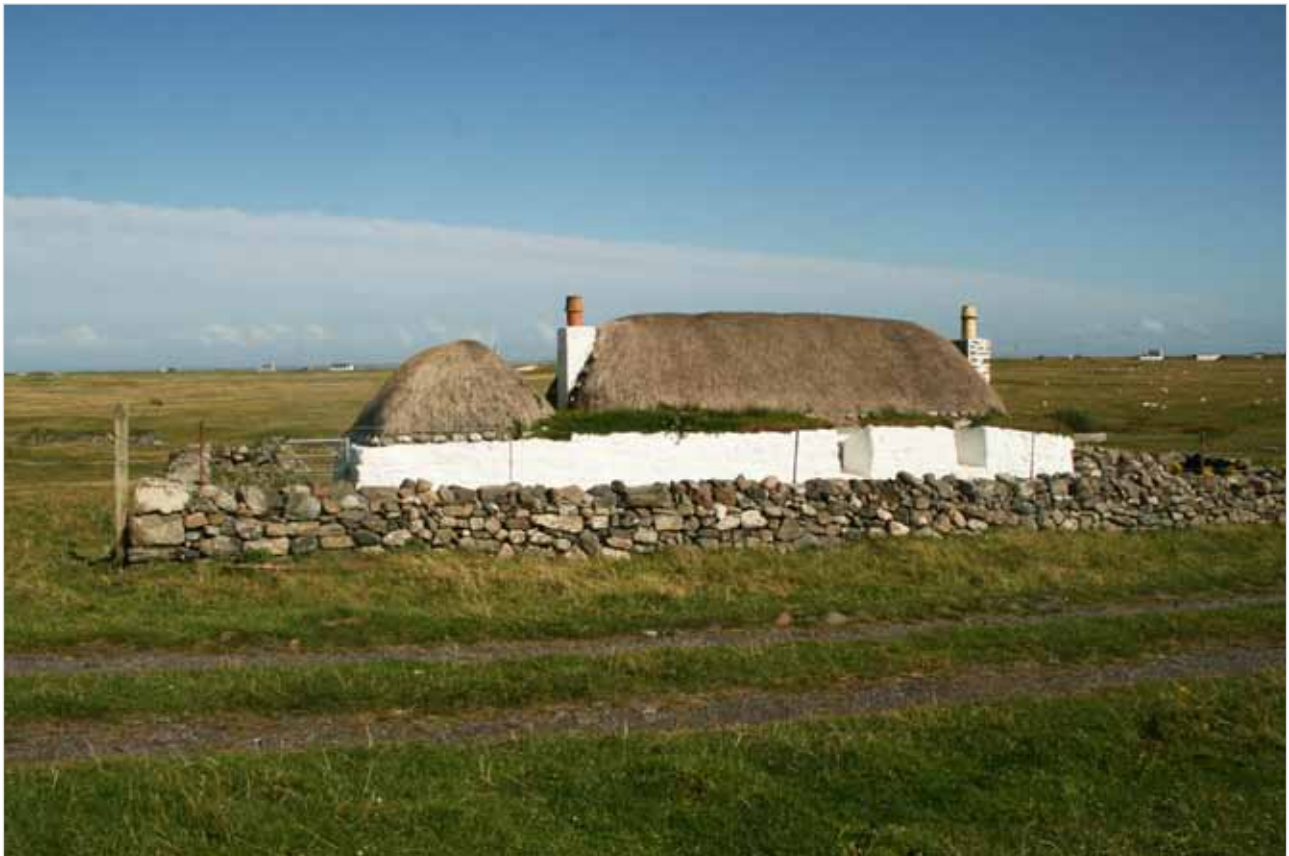
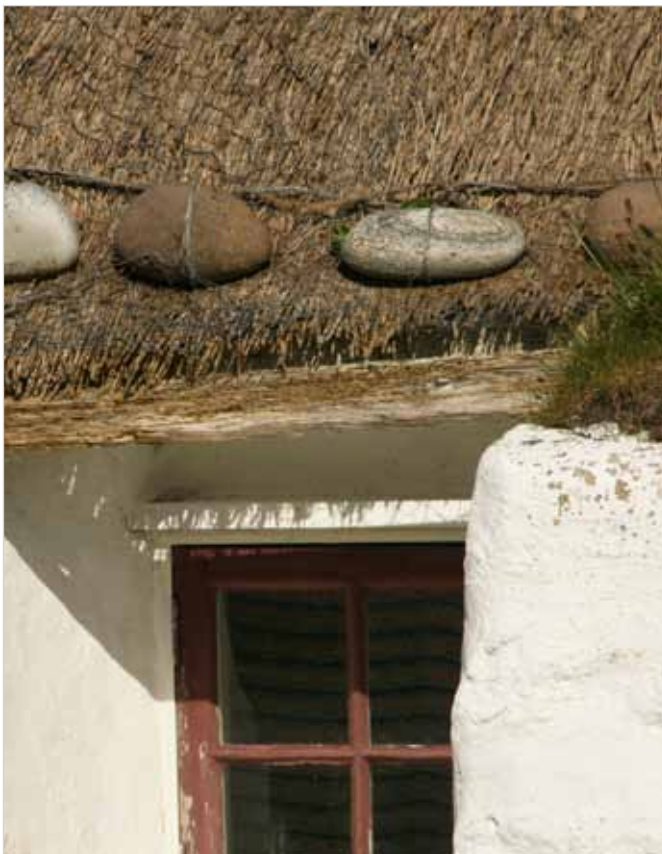
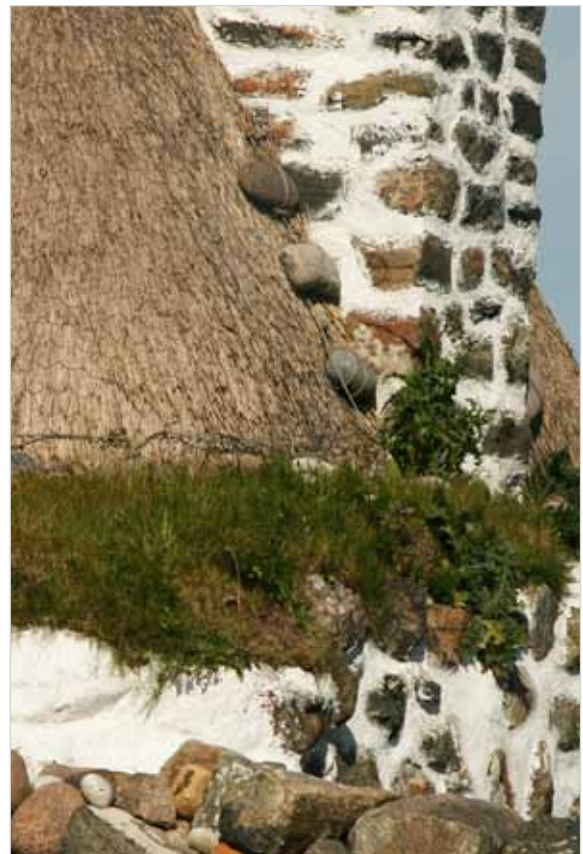
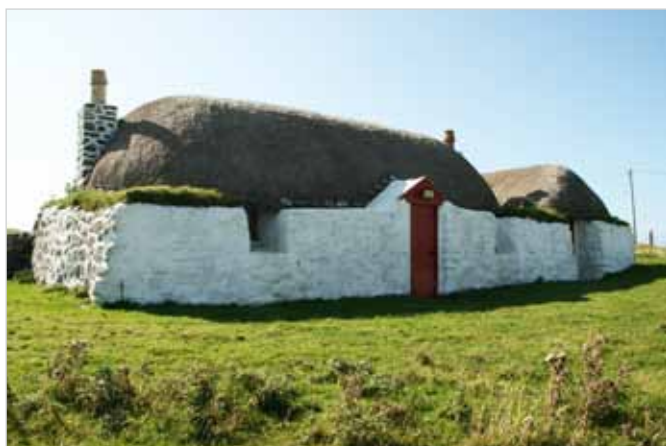
Balevullin Cottage – Argyll & Bute

**Additional Notes:** 19th-century cottage with adjoining byre to the north, both listed as having a '*thatched piended roof*'. The roofs of both the cottage and barn are thatched in marram, each with a continuous marram ridge. Both roofs have been completely netted, including across the ridge, which has been weighted down with stones and thin ropes just above the wallheads and openings, and down the sides of the chimney stacks of the cottage. Turf has been placed upon the wallheads around part of the cottage and barn, whilst some parts of the wallheads have been left exposed. The notes of the listing entry record that the '*cottage [was] modernised*

*in 1982*' and the barn was '*restored in traditional fashion in 1985*'.

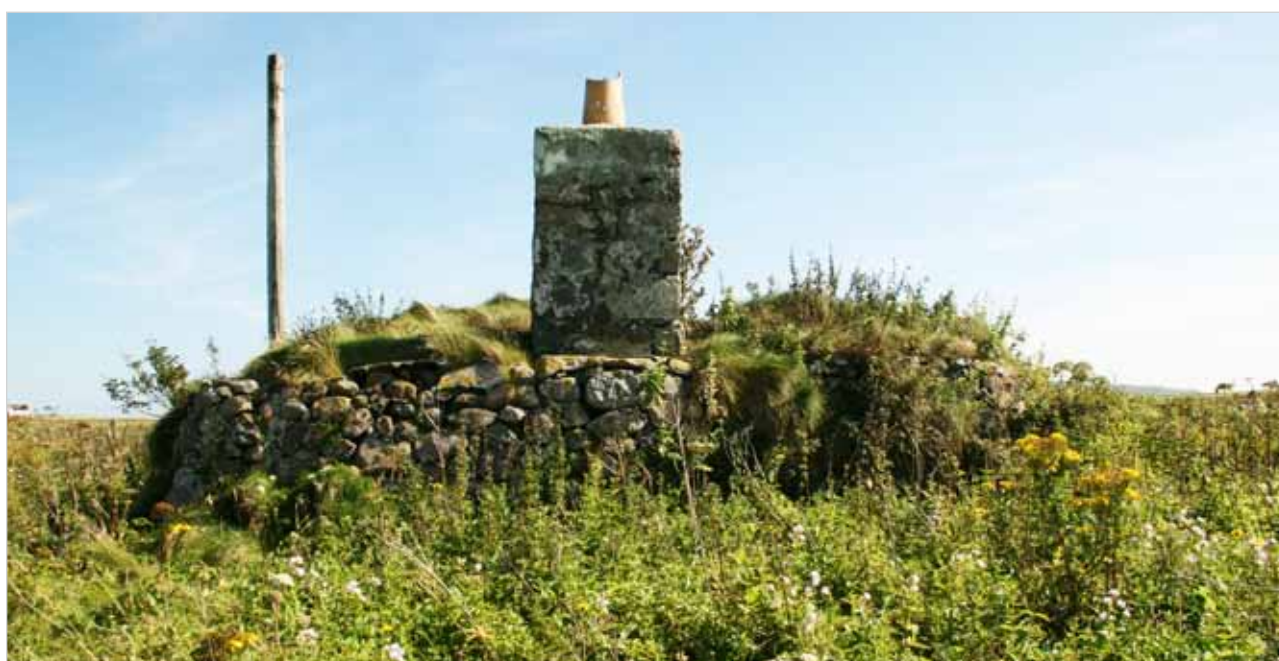
**Additional Notes:** ..... 19th-century single-storey cottage, listed as being thatched. The building, however, is now in a ruinous condition and no thatch remains. It has been on the Buildings at Risk (BAR) Register since 2009 (BAR reference number 3876) with inspection notes from this time stating the roof had already collapsed. The building is entry number 9 in the Argyll & Bute District Council Thatched Building Survey of Mull, Coll & Tiree (1986) where it is noted as having been derelict for many years with the roof being in an advanced stage of decay. The listing description should be updated accordingly.

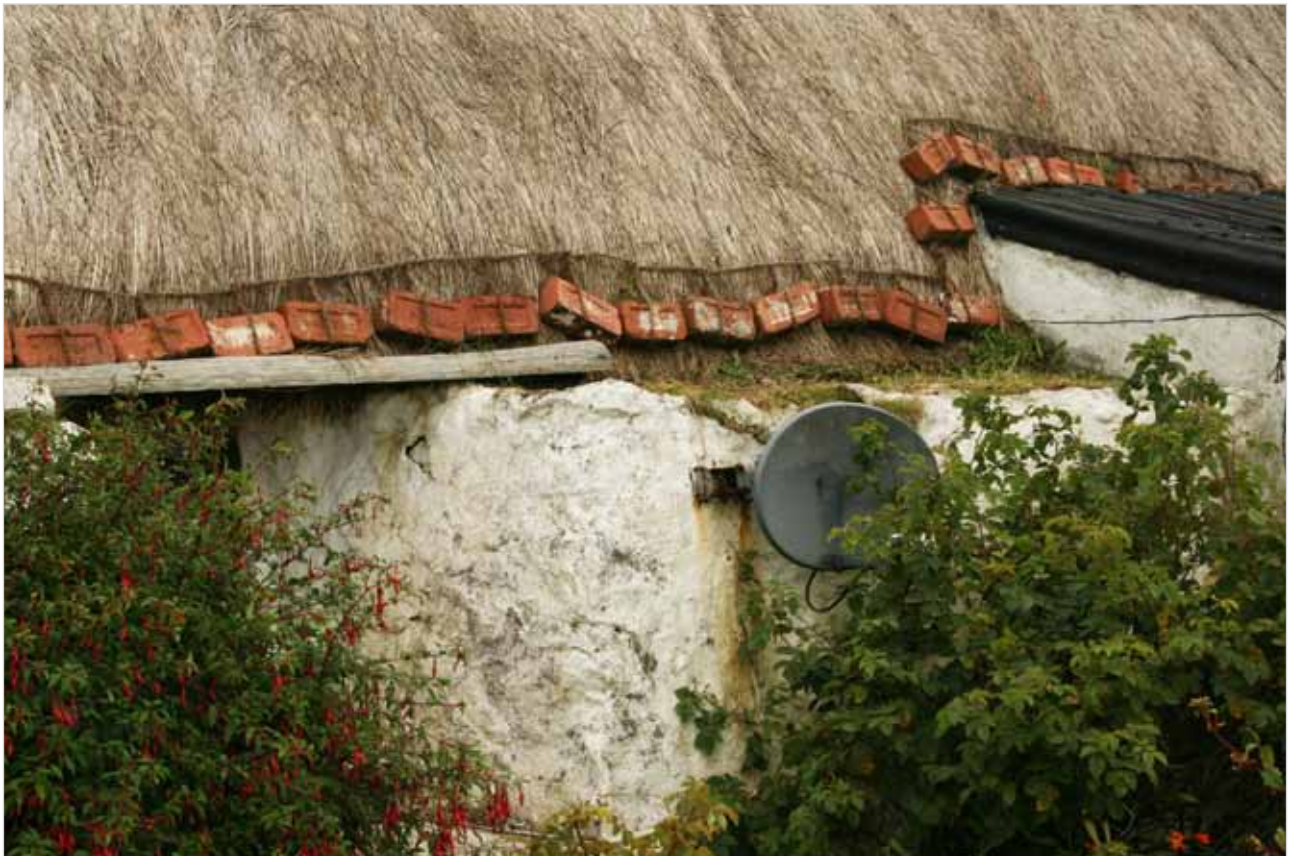
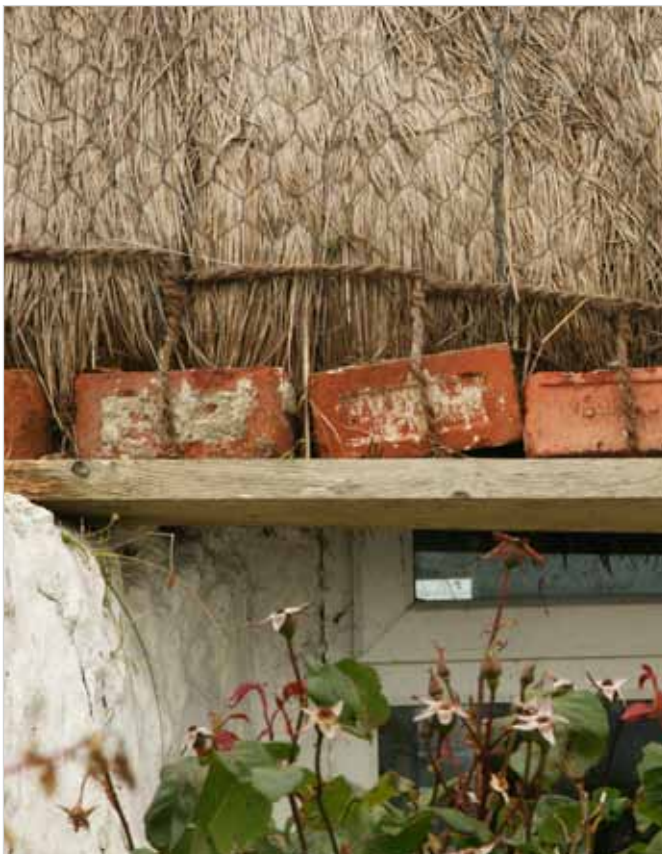
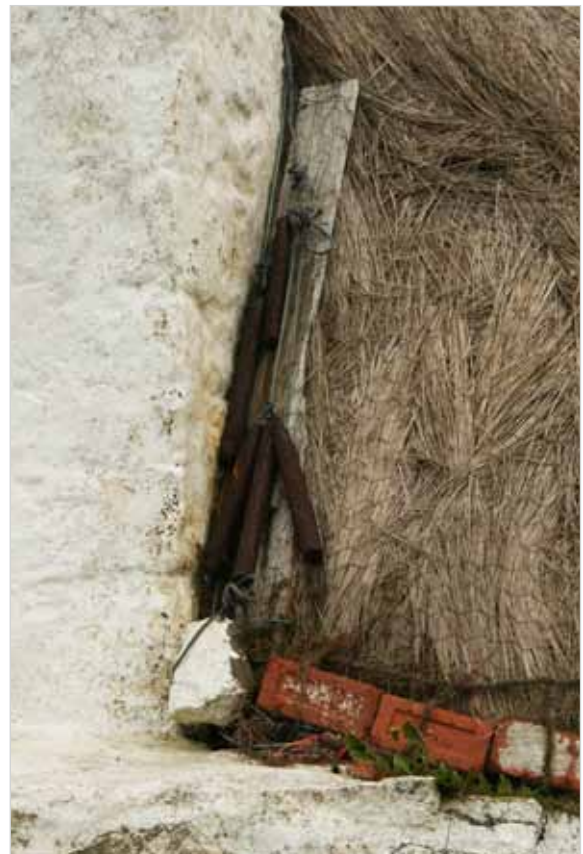
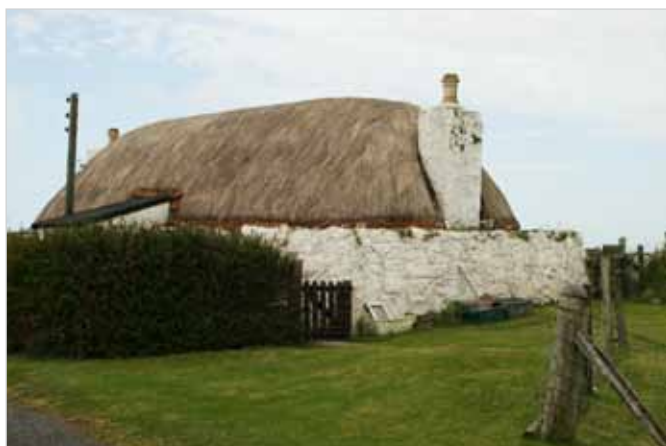
Clachan Dubh – Argyll & Bute

**Additional Notes:** 19th-century traditional cottage with 'small wood and corrugated iron porch'. The building is thatched in marram and has a continuous marram ridge, which has been netted all over, including across the ridge. The netting has been weighted with bricks and thin ropes, which sit just above the wallhead. The bricks are also used above openings and above the roof of the porch. Down the sides of the chimney stacks at either end, planks of wood have been placed underneath the netting, which have been weighted down with metal poles tied with string to the outside of the netting, providing further protection to this slightly more vulnerable junction

of the thatch. Wooden boards have been placed upon the wallheads across the window openings. The grid reference identified by the listing and by Canmore is slightly inaccurate as it indicates a small cluster of farm buildings on the same site to the north of the cottage. This should be updated.

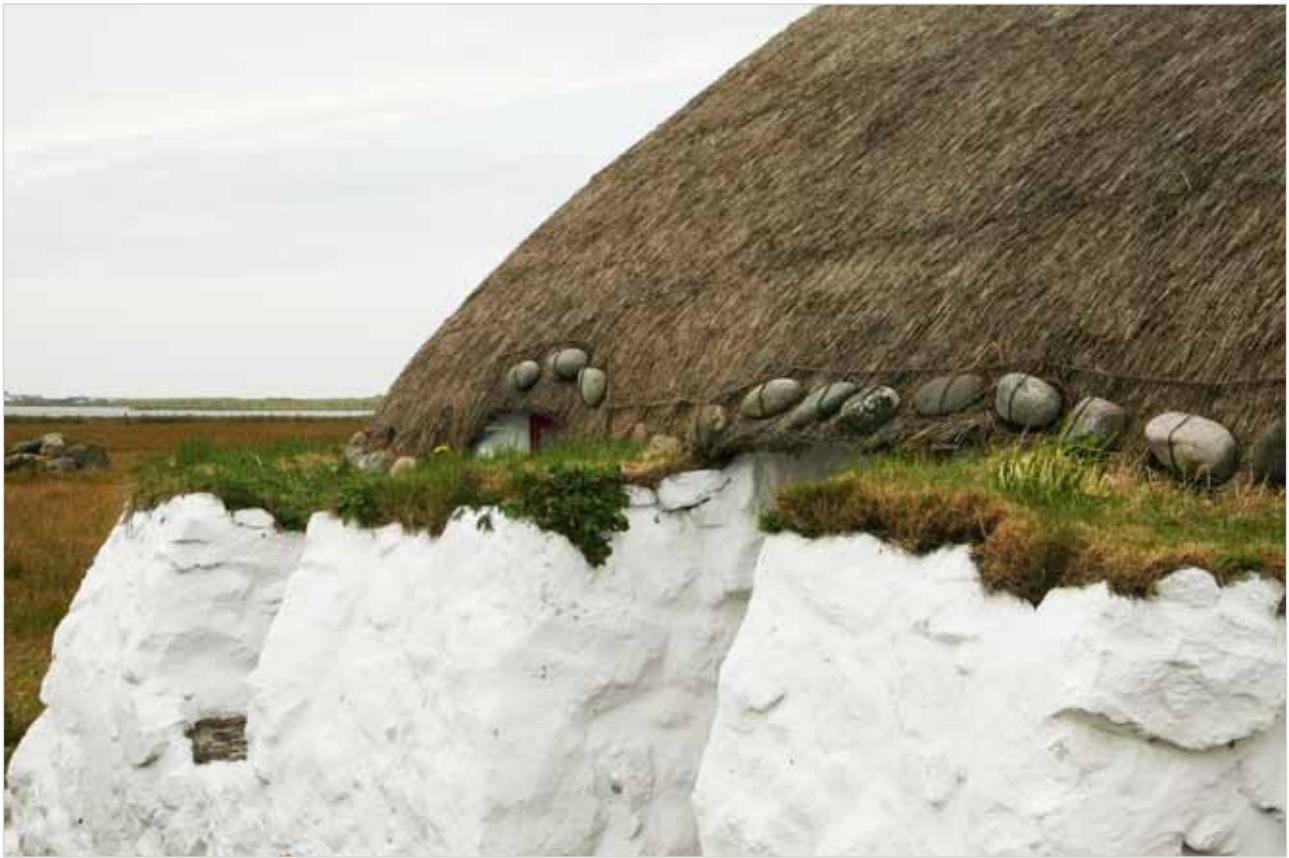
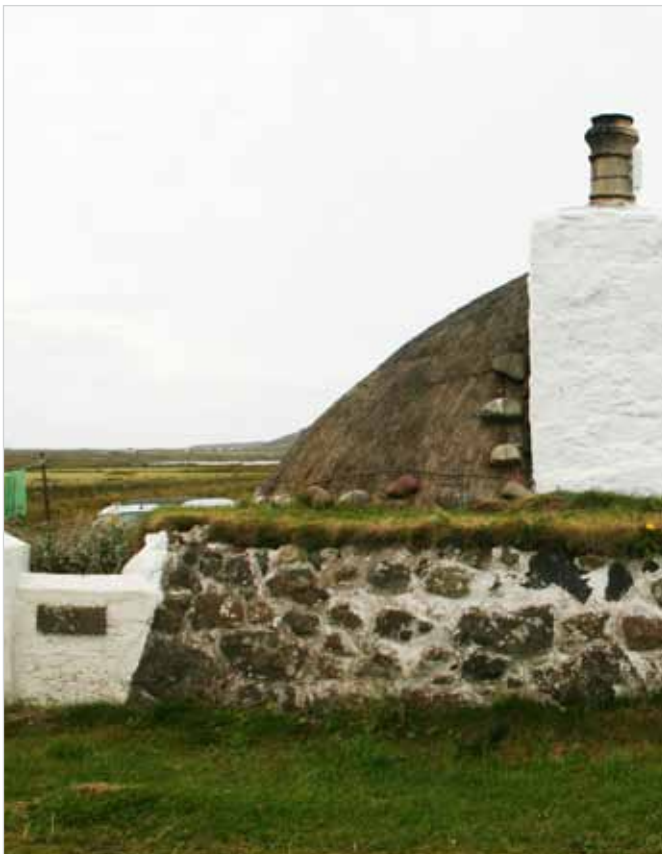
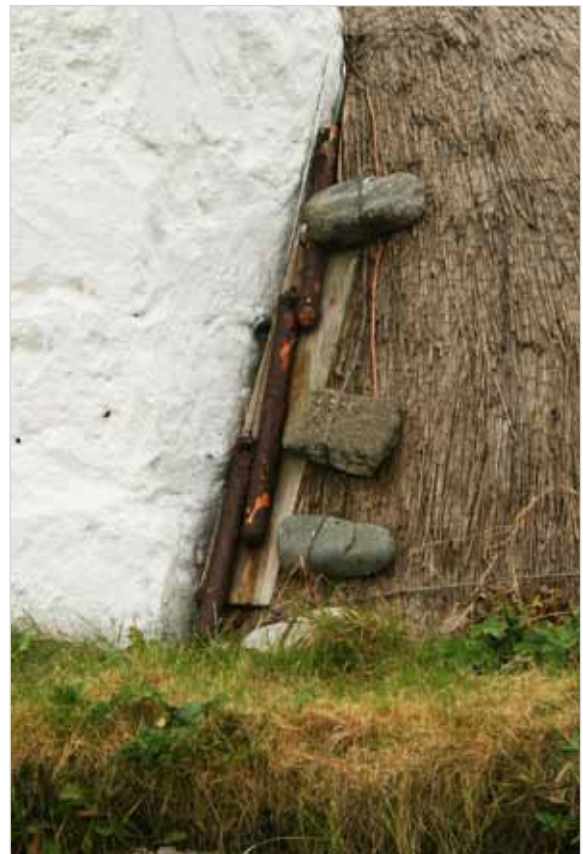
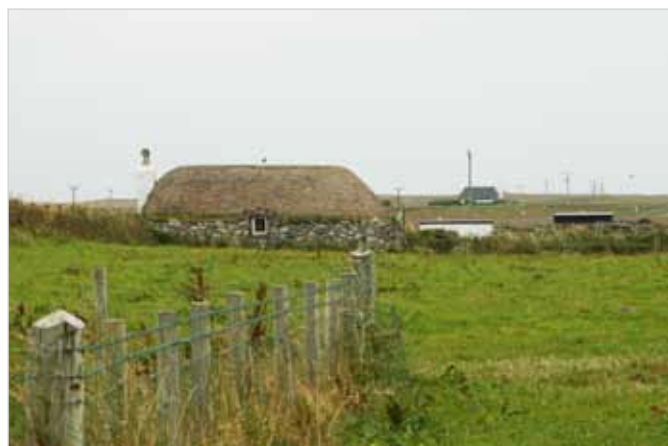
Drovers Cottage – Argyll & Bute

**Additional Notes:** Small 19th-century cottage listed as having a '*piended thatched roof*. The roof is thatched in marram, the traditional material used on Tiree, and has been netted all over, including across the continuous marram ridge. The netting, which has a wide gauge, has been weighted down by stones secured to the netting by thin ropes, running just above the wallhead and above the window and door openings around the entire circumference of the building. The stones and rope also run around the edge of the chimney stack on the north gable, but here additional weights have been used in the form of cast-iron weights. These weights appear

to be used primarily to hold in position planks of wood that have been placed vertically on either side of the chimney stack, presumably put in place to protect this slightly more vulnerable junction of the thatch.

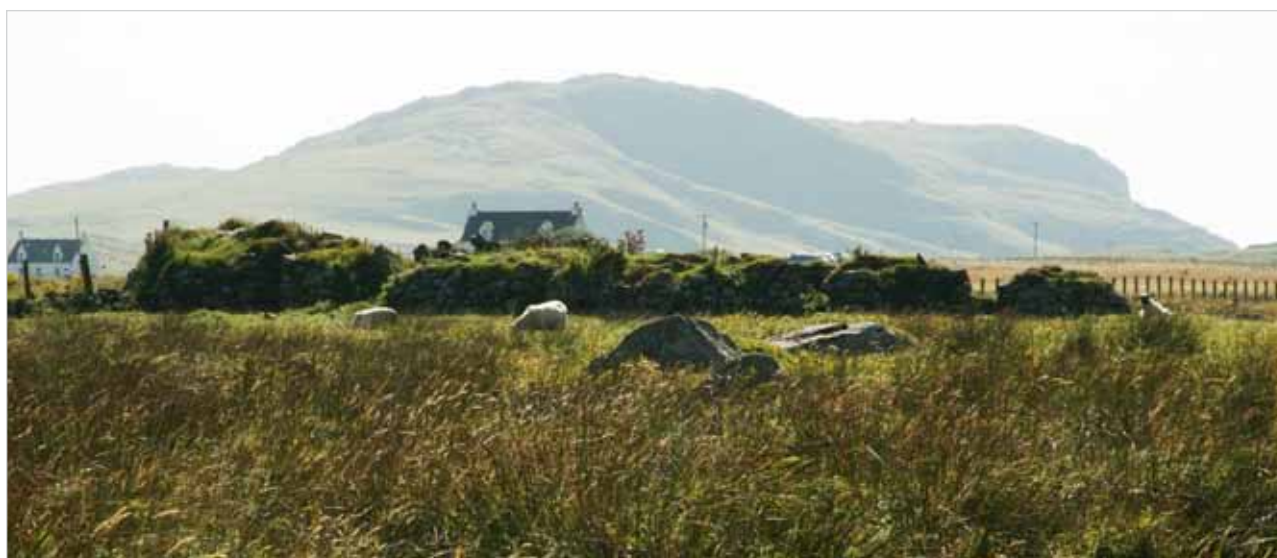
**Additional Notes:** ..... 19th-century cottage, listed as having a '*piended thatched roof*'. This building is entry number 16 in the Argyll & Bute District Council Thatched Building Survey (1985), and in another survey by John Wilson Associates (February 1986). In 1985, the property is noted as being in use as a holiday home and last being thatched the year previously, however in the 1986 survey it is noted as being '*unoccupied*', and the condition of the thatch is described as being '*poor becoming overgrown with weed*'. Also in 1986 the thatch is noted to have been weighted with '*stones on hemp rope - some missing*'. Currently the building is a ruin and has been on the Buildings at Risk (BAR) Register since 2009 (BAR reference number 3877). BAR inspections in 2008 and 2012 also note the buiding to be a '*ruinous shell*'. The listing description should be updated accordingly.

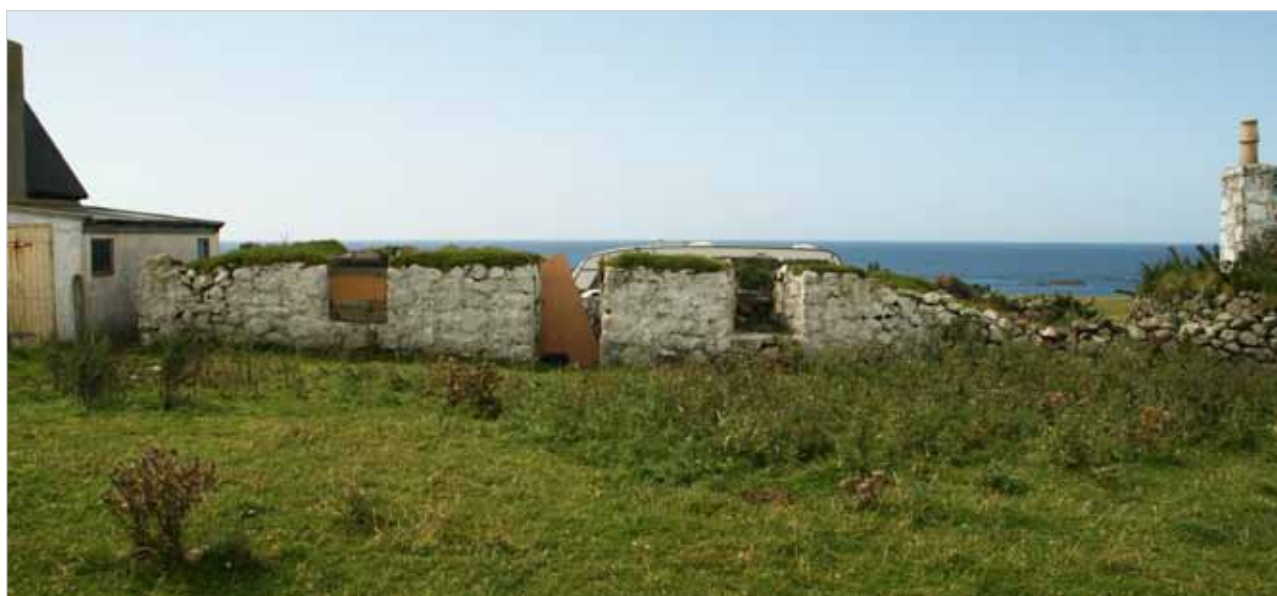
**Additional Notes:** ..... This 19th-century cottage was listed in 1981 as part of a group listing along with the cottage to the north of this. It is listed as having a '*piended thatched roof*', with the listing notes reading '*The Terrace is unusual row of 3 traditional thatched cottages*'. The building has been on the Buildings at Risk (BAR) Register since 2012 (BAR reference number 5290), at which time it was recorded as being '*ruinous*'. The building was once part of a row of three traditional thatched cottages, this one being the central – the north cottage is still thatched but is in a derelict condition and the south cottage now has a tar felt roof. The listing description for this building should be updated accordingly.

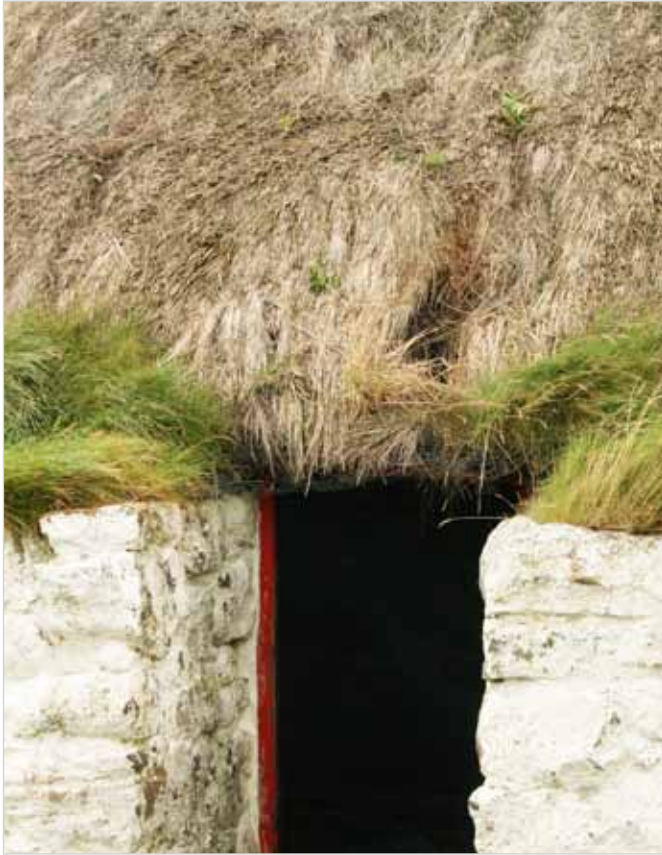
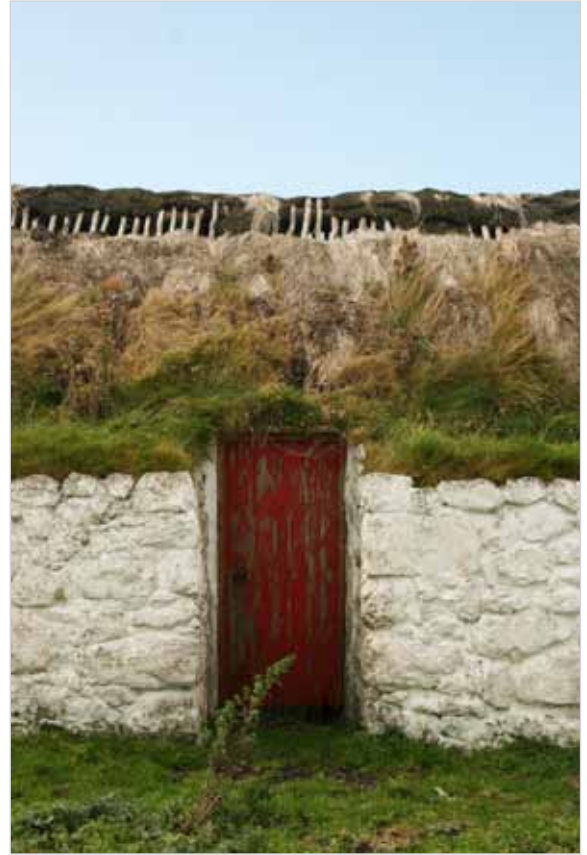
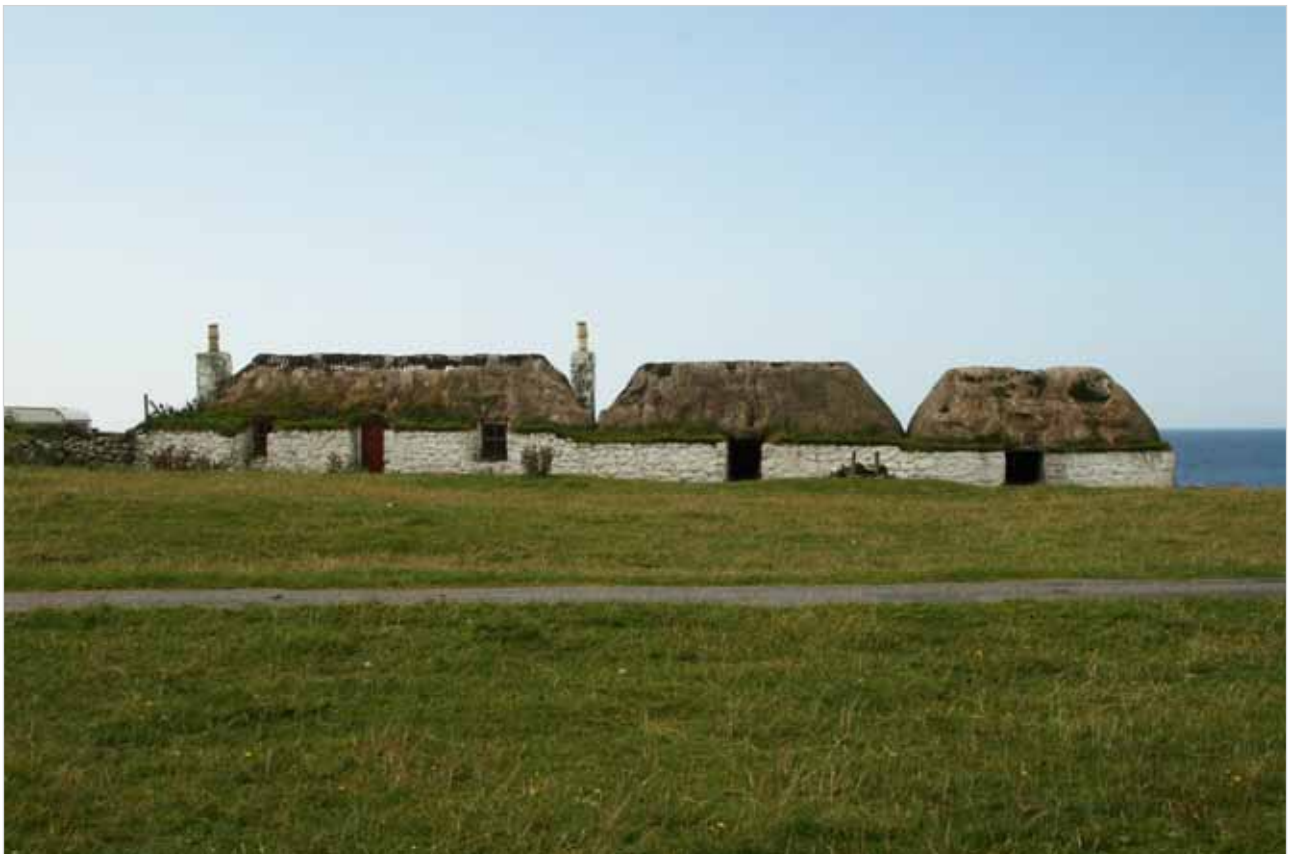
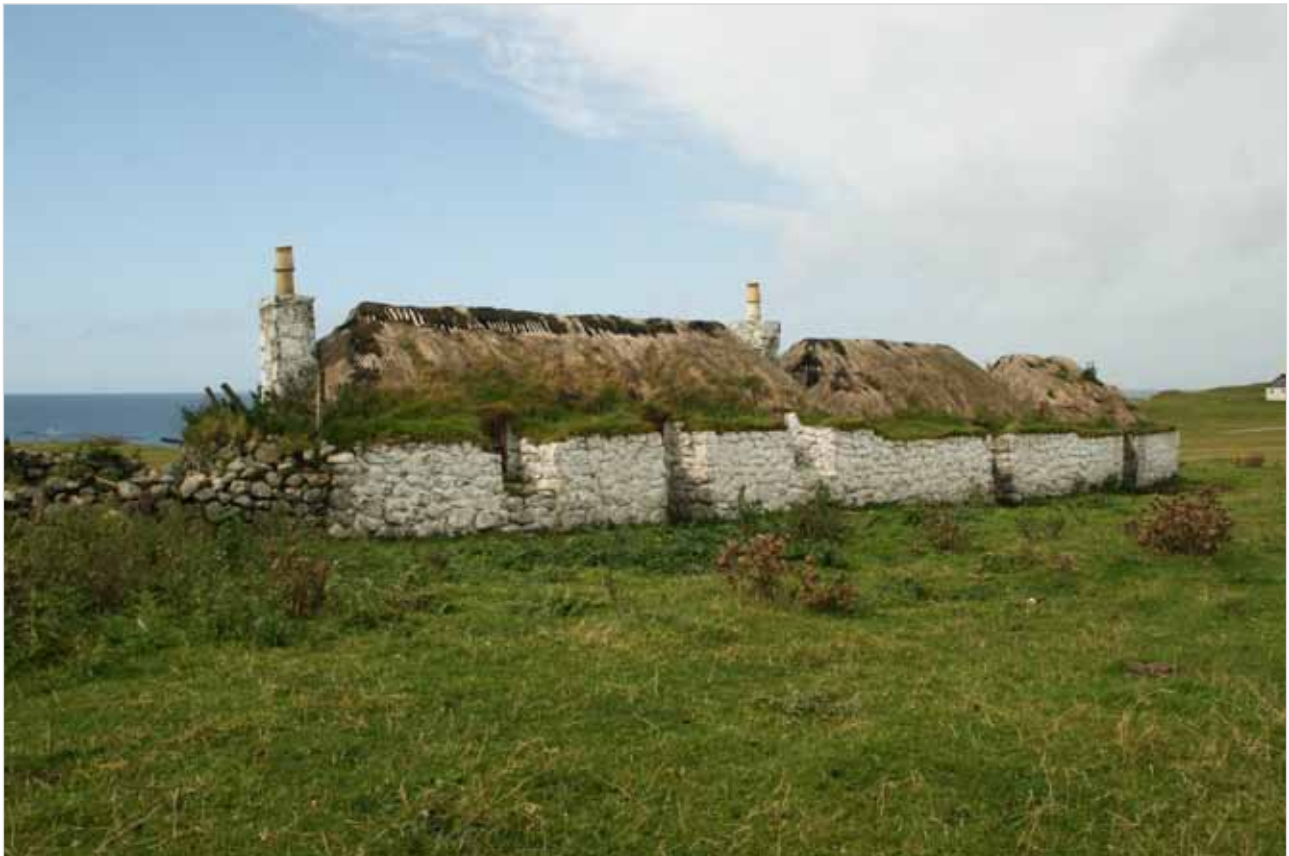
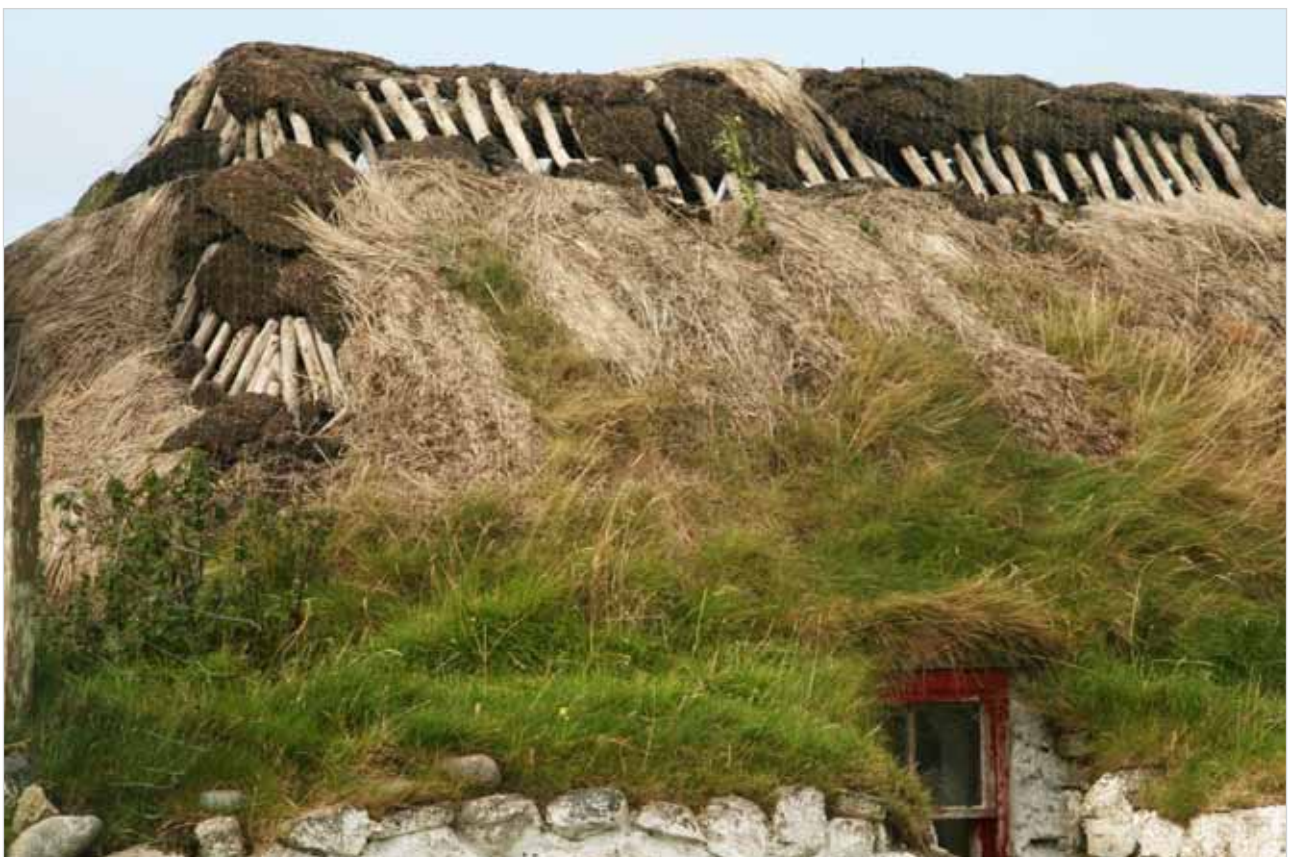
The Terrace (North Cottage) – Argyll & Bute

Additional Notes: ..... 19th-century cottage with adjoining barn and byre to the north. All three buildings were listed in 1981 as having piended thatched roofs, as part of a group listing with another cottage to the south. This cottage is the northern most in a row of three traditional cottages, all originally, and at the time of listing, with thatched roofs (the central cottage is now a ruin and the southern cottage has a tar felt roof). The cottage, barn and byre are in a derelict condition and the thatched roofs have deteriorated significantly. The roofs are thatched in marram and appear to have had continous marram ridges, though this has been lost in most places. There is visible evidence of having been netted, though, due to the overgrown nature of the turf upon the wallheads, no weighting devices can be seen to be holding the netting in place. There are large holes in the thatch, with much of the marram missing, exposing the turf underlay and the interior of the building. The cottage, barn and byre have been on the Buildings at Risk (BAR) Register since 2012 (BAR reference number 5408), at which time the roof was also recorded as having '*holes on their west facing thatched roofs*' and being '*currently disused*'. According to BAR notes the building was last in use as a museum and by 2012 full Planning Permission and Listed Building Consent were being sought to change the use to two dwellings and a store. The current status of these applications is unknown.

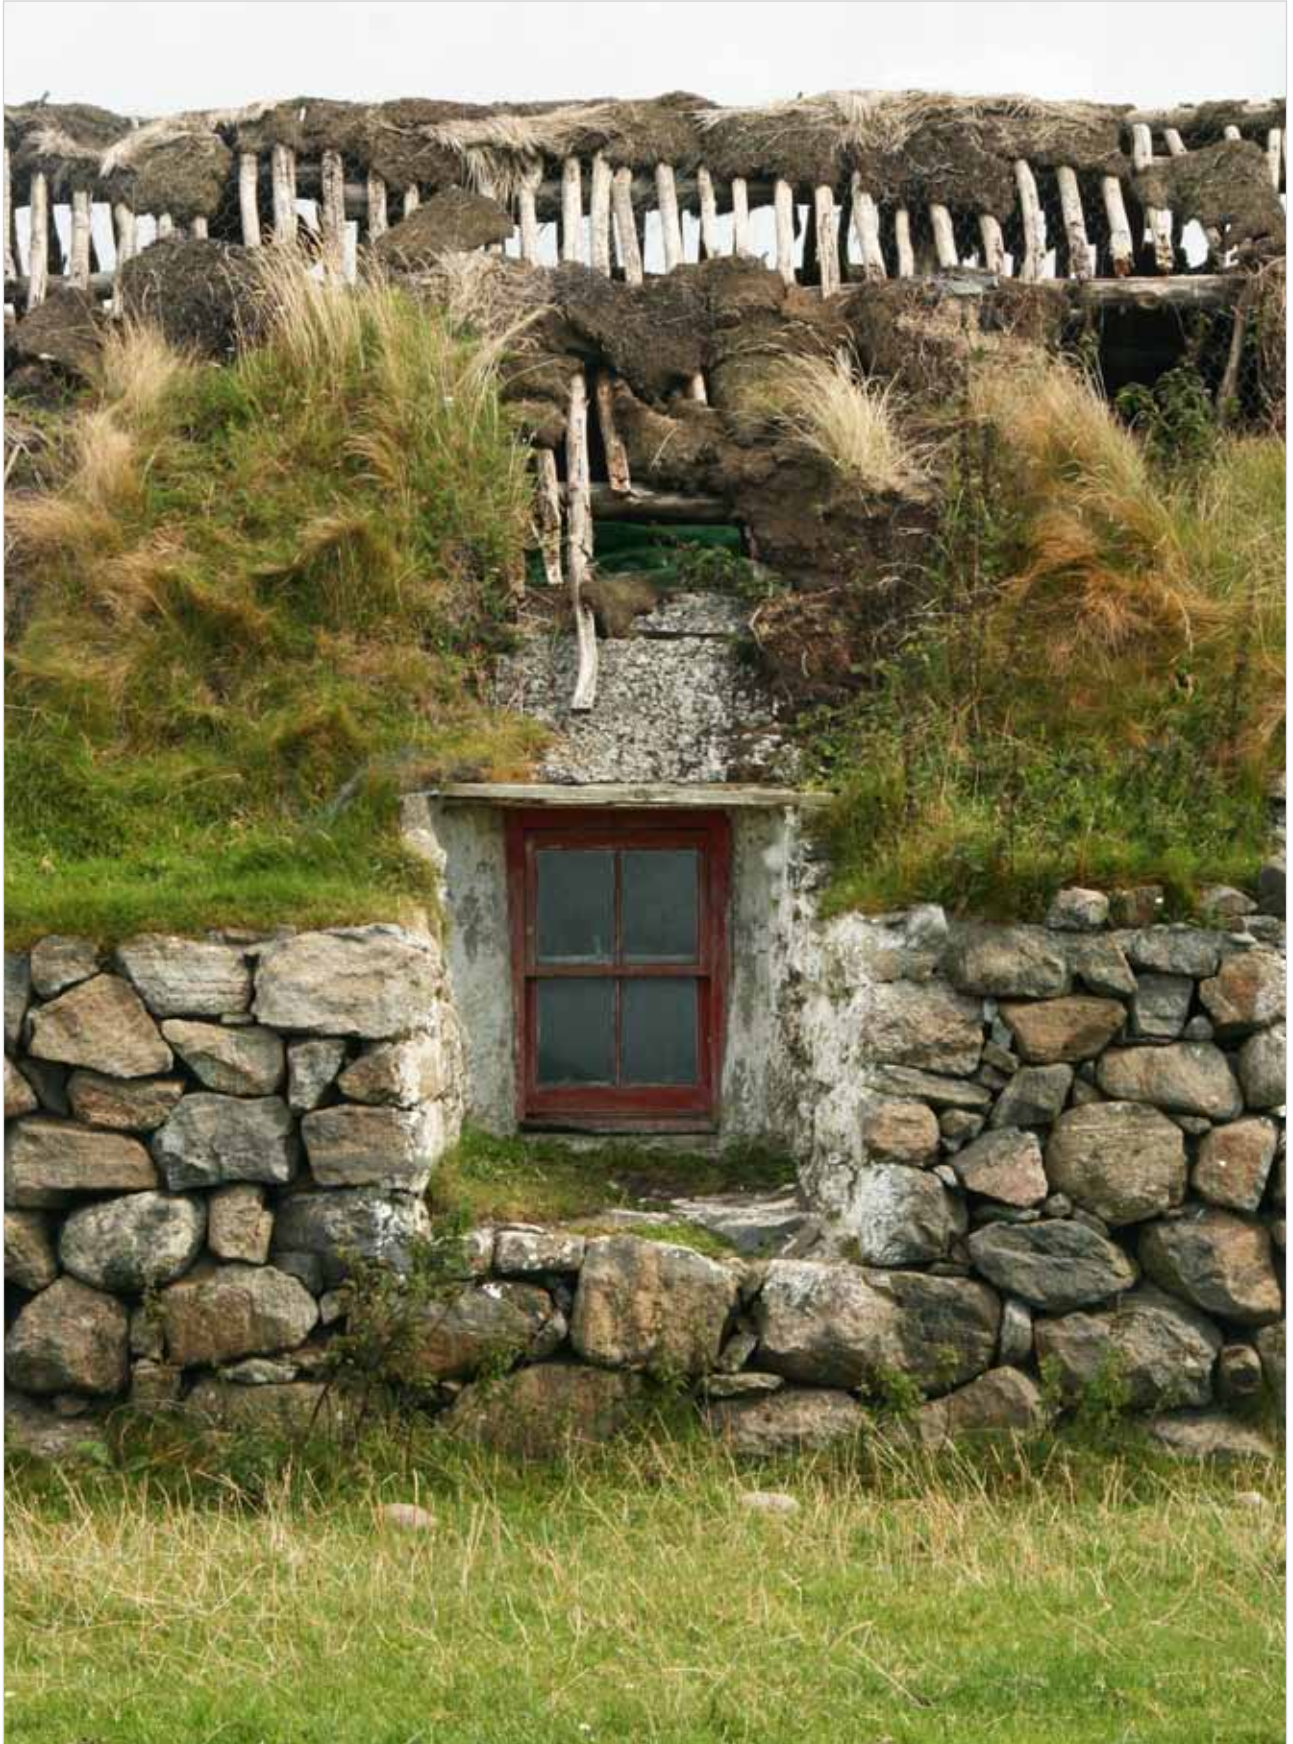
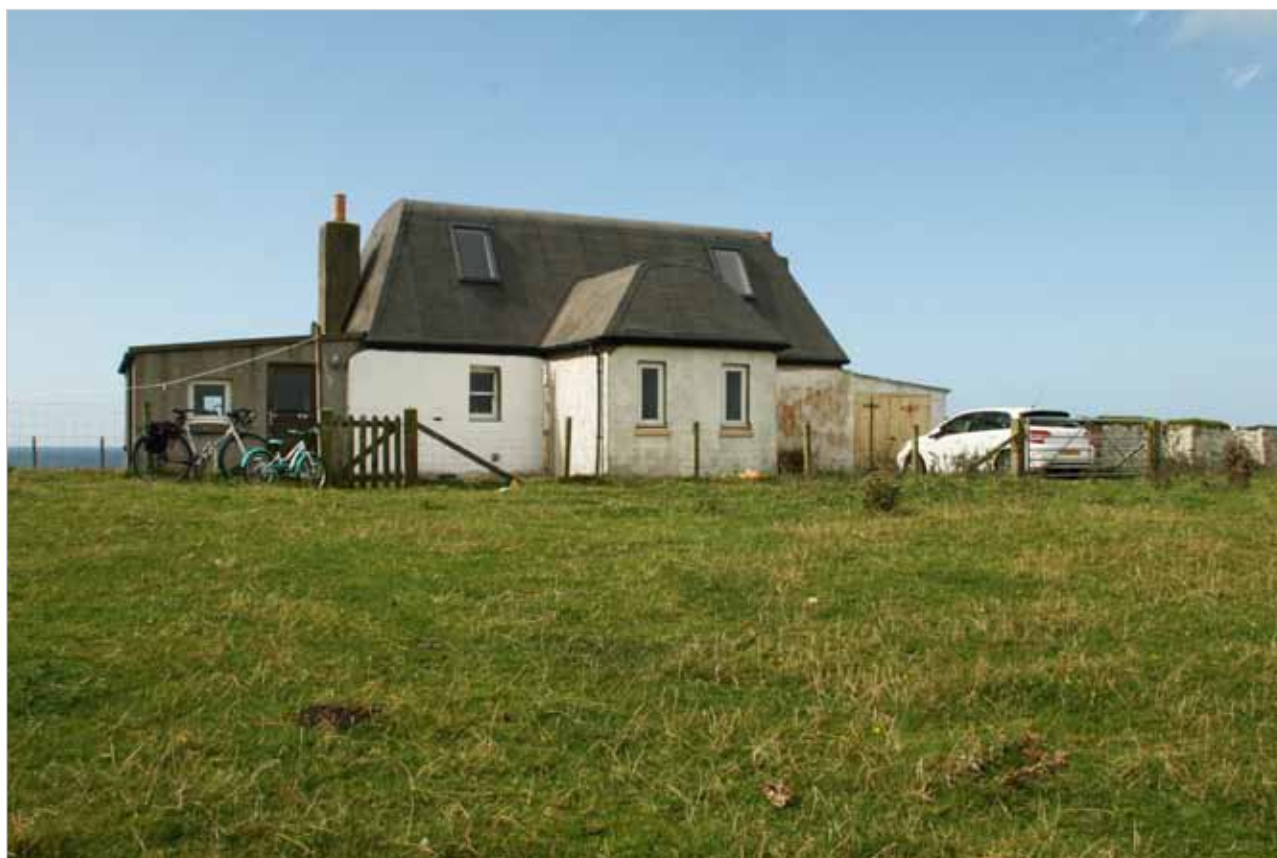
Additional Notes: ..... Circa 1930 cottage, the southernmost in a row of cottages called 'The Terrace'. It was listed in 1981 as having a '*piended thatched roof with overhanging eaves*'. The building now has a tar felt roof and no thatch remains. The listing description for this building should be updated accordingly.
